## Feasibility Analysis of Old Building Structures Manado State Polytechnic Campus

Julius E. Tenda<sup>1</sup>, Denny B. Pinasang<sup>2</sup>, Mycle Wala<sup>3</sup>, Merci F. Hosang<sup>4</sup>  
Manado State Polytechnic

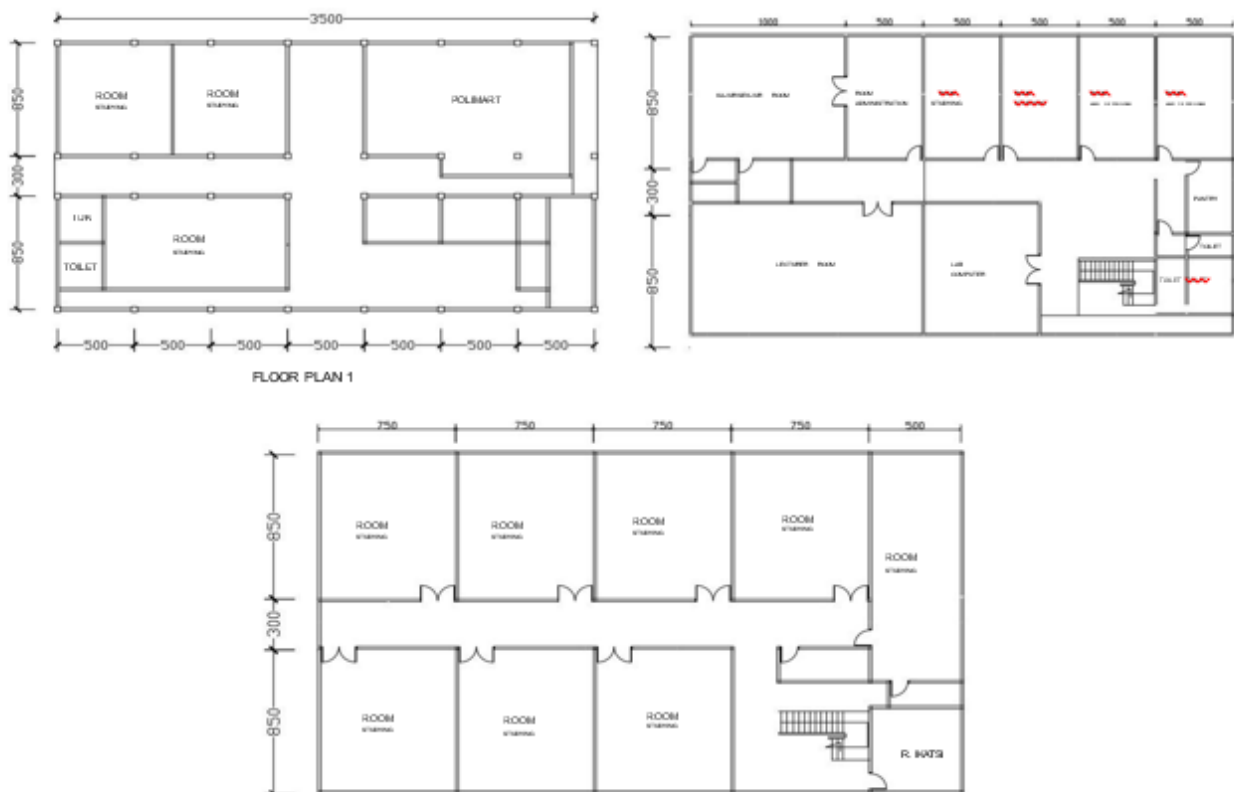
Figure 1. Civil Engineering Department Building Plan

The Civil Engineering Department building is built with a 3-story construction with an area of each floor as follows:

Floor 1 : 700 m<sup>2</sup>

2nd Floor : 700 m<sup>2</sup>

3rd floor : 700 m<sup>2</sup>

With a total area of 2100 m<sup>2</sup>

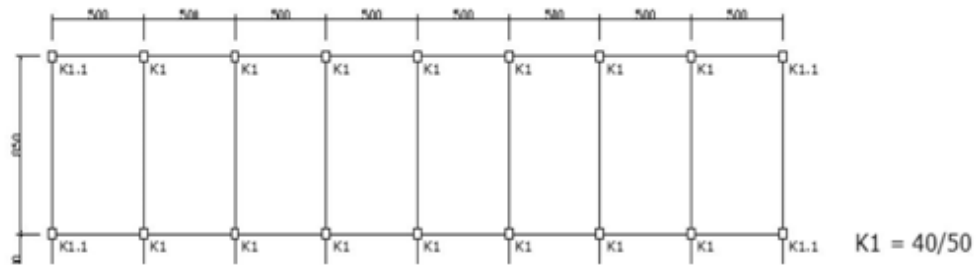
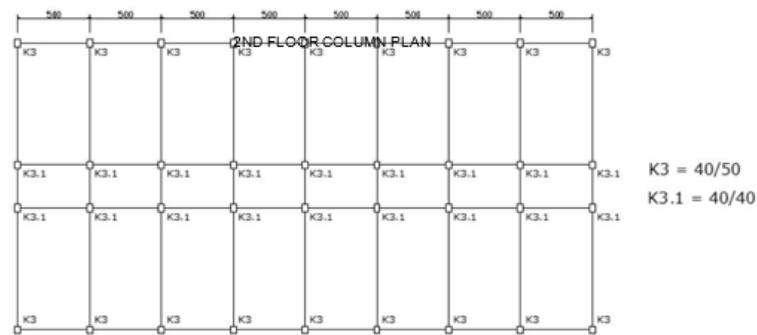
Figure 2. Column Plan of Civil Engineering Department Building

Checking the conformity of as- Built Drawing with Civil built drawings with the field After Engineering Department Building, conducting an inspection in the field, State Polytechnic Manado. no differences were found between
